The Uniform Building Inspection Report™

Single Family Residence:
3648 Eaglet , Any town, USA 44444

Inspection Date:
10/5/2015, 12:30:00 PM

Inspection Company:
Center Grove Real Estate Inspections, LLC
Jim Schwarz, Lic.# HI00600105
3620 Tallwood Lane,
Greenwood, IN 46143
317-313-5362
Web Site: www.centergroveinspections.com
jim@centergroveinspections.com

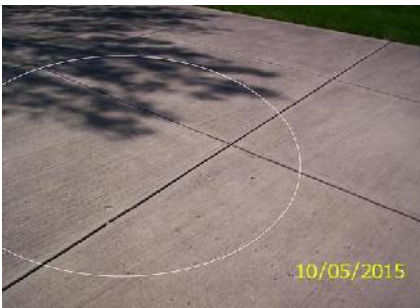
Photo: 0210.01 (1)

[P] 0210.01: Concrete cracks noted.
It is suggested to caulk expansion joints to prevent moisture intrusion which leads to settlement and cracks in concrete. A very useful self-leveling caulk is the brand of PL/Loctite for this application.
See Photo(s) 0210.01.

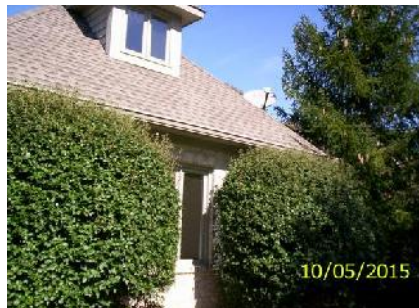
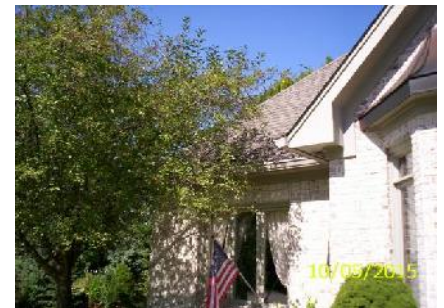
[P] 0860.02: Shrubbery against building.
Suggest trimming of any shrubs that touch home to improve air circulation, prevent insect intrusion and damage to siding.
See Photo(s) 0860.02.

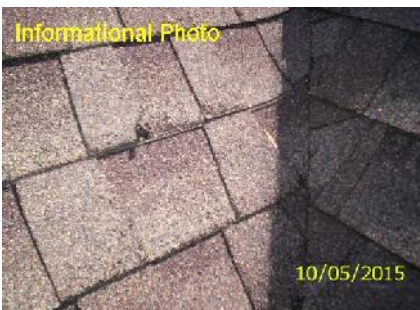
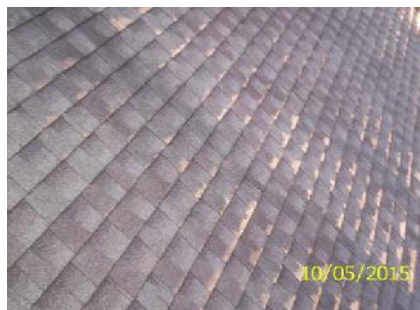
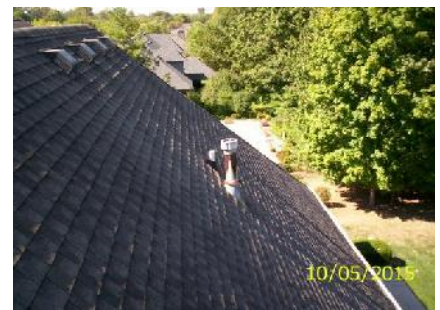
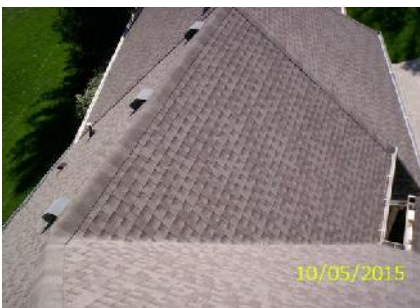
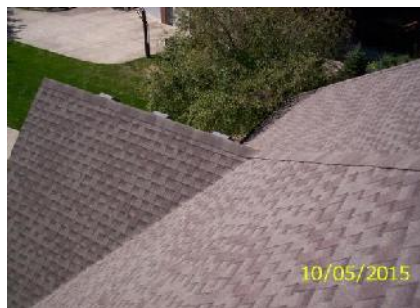
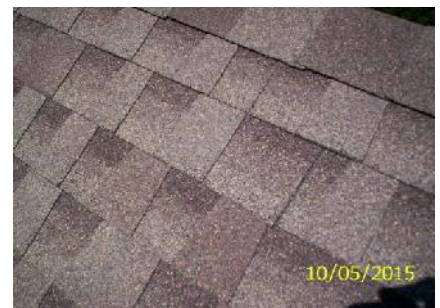
[Note] 1010: Roof weathering, showing signs of aging.
Suggest annual inspection of roof for necessary repairs to extend roof life.
The roof is approximately midpoint of its service life.
See Photo(s) 1010.

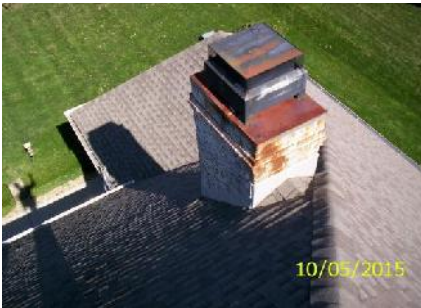
Photo: 1900.01 (1)

[P] 1900.01: Spot painting recommended.
Chimney chase cover is beginning to rust. It is suggested to paint area to prevent deterioration and staining of siding.
See Photo(s) 1900.01.

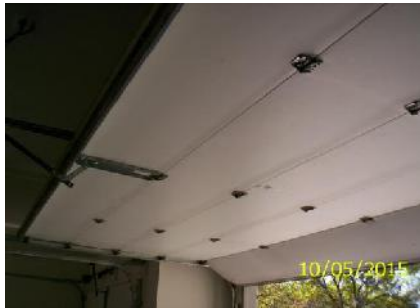
Photo: 1950.02 (1)

[P] 1950.02: Informational Photo and Comments
It is suggested to oil all hinges, rollers, springs, cables and tracks to allow door to operate smoothly. Use of light oil in aerosol can is the best application method.
Don't forget to ask the seller for remote openers.
See Photo(s) 1950.02.

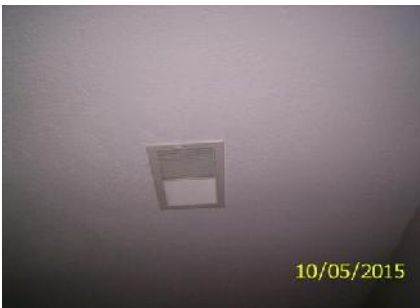
Photo: 2260.10 (1)

[E] 2260.10: Uneven distribution.
It is recommended to leave all supply and return register open in the home for even air distribution.

[E] 2260.10: Uneven distribution.
It is recommended to leave all supply and return register open in the home for even air distribution.
See Photo(s) 2260.10.

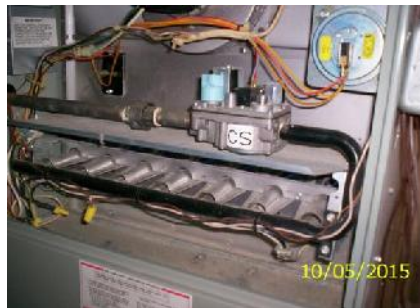
Photo: 2940.01 (1)

[R] 2940.01: Unit appearance questionable. The furnace is operating in a normal manner. However, its appearance and characteristic roar sound of the burner assembly indicates this unit has not been routinely serviced. It is recommended to have this unit cleaned and serviced for dependability purposes. Cleaning should include the burner assembly, fan assembly and the evaporator core, as well as a borescope review of the heat exchanger. Service should include determining the integrity of the blower fan motor/capacitor, draft inducer fan and the ignitor.
See Photo(s) 2940.01.

[R] 2940.01: Unit appearance questionable.
The furnace is operating in a normal manner. However, its appearance and characteristic roar sound of the burner assembly indicates this unit has not been routinely serviced.
It is recommended to have this unit cleaned and serviced for dependability purposes.
Cleaning should include the burner assembly, fan assembly and the evaporator core, as well as a borescope review of the heat exchanger.
Service should include determining the integrity of the blower fan motor/capacitor, draft inducer fan and the ignitor.
See Photo(s) 2940.01.

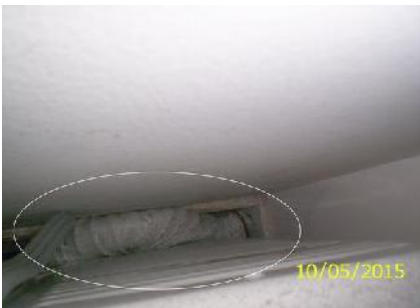
Photo: 4810.21 (1)

[U] 4810.21: Dryer vent improper.
Suggest installation of flexible metal ductwork to prevent fire safety hazard.

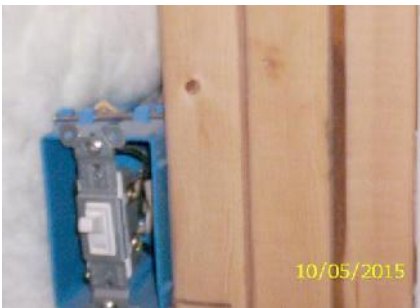
Photo: 5640.01 (1)

[P] 5640.01: Interior face or cover plate needed.
Noted on the main attic light switch.
See Photo(s) 5640.01.

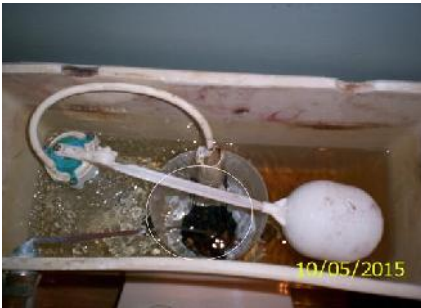
Photo: 6260 (1)

[P] 6260: Water closet tank ball or flapper valve worn and currently leaks.

It is suggested to replace the flapper valves on each toilet to improve dependability of preventing water loss.

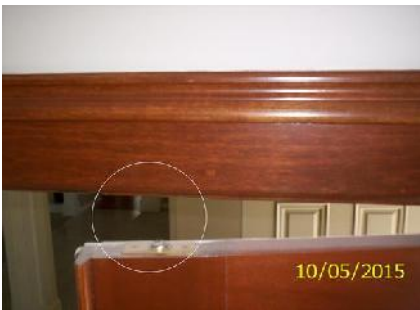
Photo: 7410.03 (1)

[P] 7410.03: Door striker or striker plate faulty or otherwise amiss.

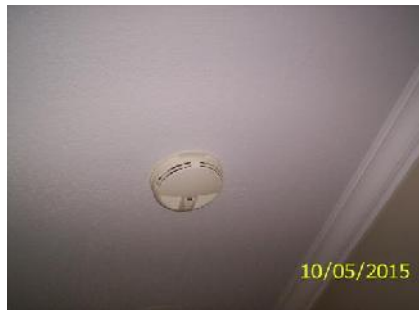
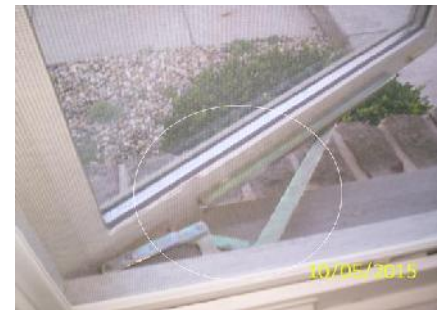
[U] 7950.02: Informational Photo and Comments
It is recommended to install new smoke alarms in the home due to age of the system. Alarms typically have a service life of less than 10 years. This establishes a new baseline for the alarms in the home.
In addition, it is recommended to install an alarm in each bedroom and living area of home.
See Photo(s) 7950.02.

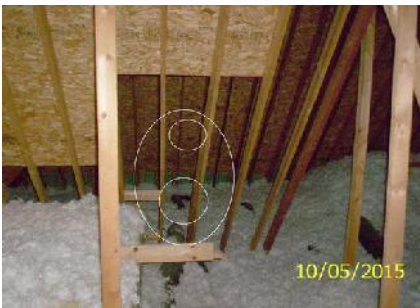
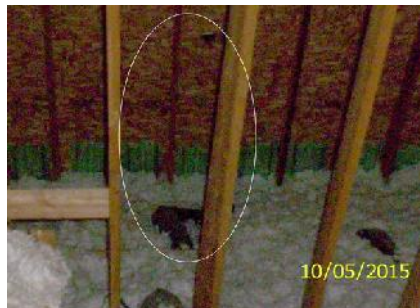
[P] 9660: Kitchen, bath, or laundry ventilation terminates in attic.
It is noted the bath vent discharge tube is separated from the roof discharge in the master bath .
Recommend repairs to route bath vent to the exterior of the home.
See Photo(s) 9660.
